# Marine Mammal Scientific Support Research Programme MMSS/001/11

## Testing the hypothetical link between shipping and unexplained seal deaths

Sea Mammal Research Unit

July 2015 (version F2)

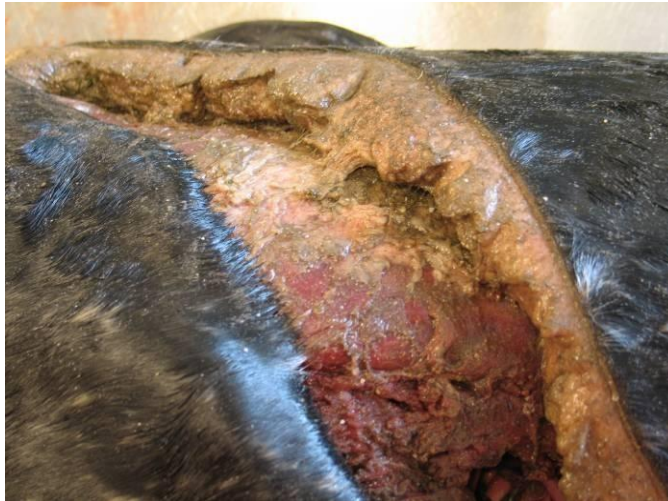
**Figure 1.** Photograph of the wound on a juvenile harbour seal. The smooth edged cut through the skin and tearing of the blubber by a lateral shearing force was common to all carcasses examined.

All of the seals had a characteristic wound consisting of a single smooth edged cut (Figure 1) that started at the head and spiralled around the body (Figure 2). In most cases the resulting spiral strip of skin and blubber was detached from the underlying tissue. The wound was identified as the cause of death in all cases for which a detailed post mortem examination was carried out. Post-mortem examinations of 20 harbour seals revealed they had been alive and healthy when the injuries were sustained, with no evidence of any underlying disease or disability (Bexton *et al.*, 2012).

Based on the pathological findings it was concluded that mortality was caused by a sudden traumatic event involving a strong rotational shearing force (Bexton *et al.* 2012). The extremely neat edge to the wound strongly suggested the effects of a blade with a smooth edge applied with considerable force, while the spiral shape of the wound was consistent with rotation about the longitudinal axis of the animal. The separation of a large section of the skin and blubber layer from the front of the carcass and avulsion of the shoulder blades in most cases, was evidence of the application of a powerful lateral force pushing the body past a rotating blade.

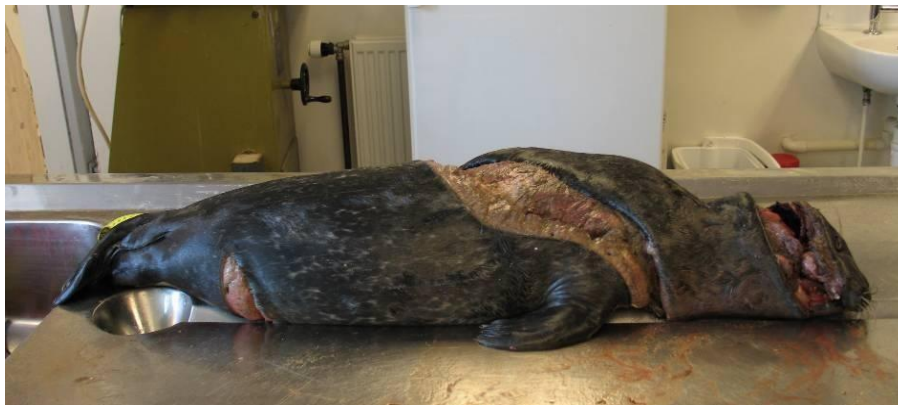
**Figure 2.** Harbour seal juvenile showing typical spiral wound. Collected in the Eden estuary in St Andrews Bay, July 2009.

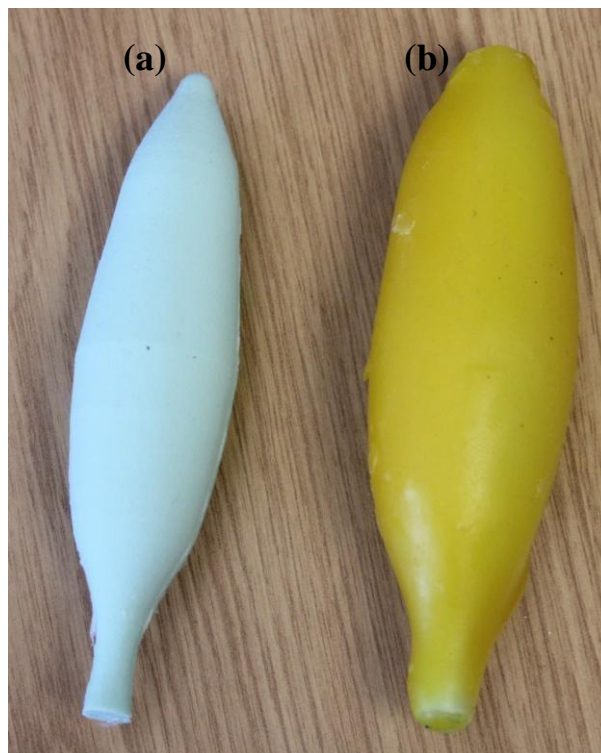
**Figure 3.** Scale replicates of (a) a juvenile grey seal body core and (b) a juvenile grey seal with a blubber layer. The body core measure 13 cm in length.

Under a research agreement with a marine propulsion engineering company (VOITH Turbo, Germany), an initial series of tests using different scale models of seals with different materials and a range of sizes were carried out. In collaboration with VOITH's engineers and fluid dynamics group, a range of prototype seal models using flexible RTV silicone to represent the body core and a low melting point, petroleum based wax to represent the sculp (skin and blubber layer) were developed (Figure 3). Preliminary versions of these seal models were tested in a simplified test rig comprising an electrically driven outboard engine fitted with a plastic propeller. Initial results suggested that the wax layer behaved in a similar fashion to the sculp of seals with corkscrew injuries. In addition to cutting and peeling in a manner similar to the recorded injuries, the wax layer retained an imprint for all impacts, including those that did not cause cuts or splits in the seal model (Figure 4).

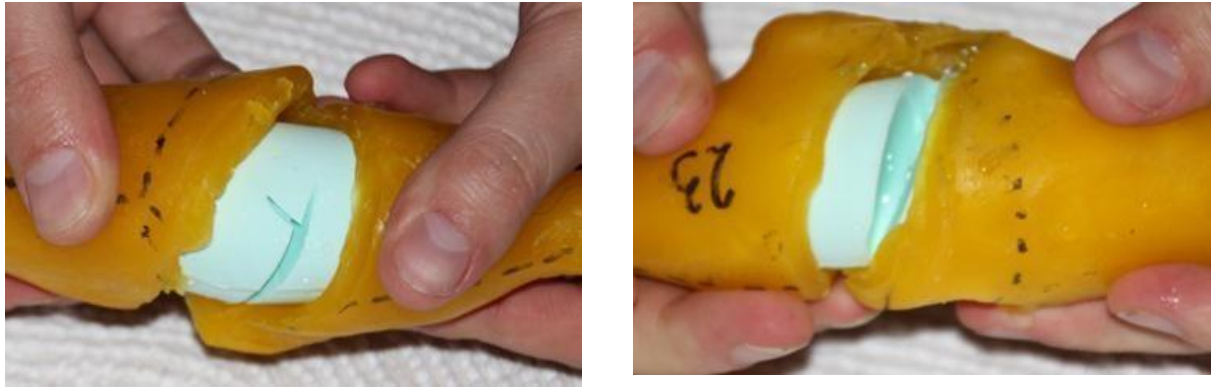
**Figure 8.** Examples of cuts to the silicone core of seal models resulting from blade impacts

During a total of 214 formal trials and a large number of ad hoc trials during preliminary testing, all the seal models either passed through or in some cases became stuck to the front of the propeller. The only examples of seal models being cut through to the core were instances where the seal model was rolled against the main support strut for the duct (Figure 7 and Figure 8).

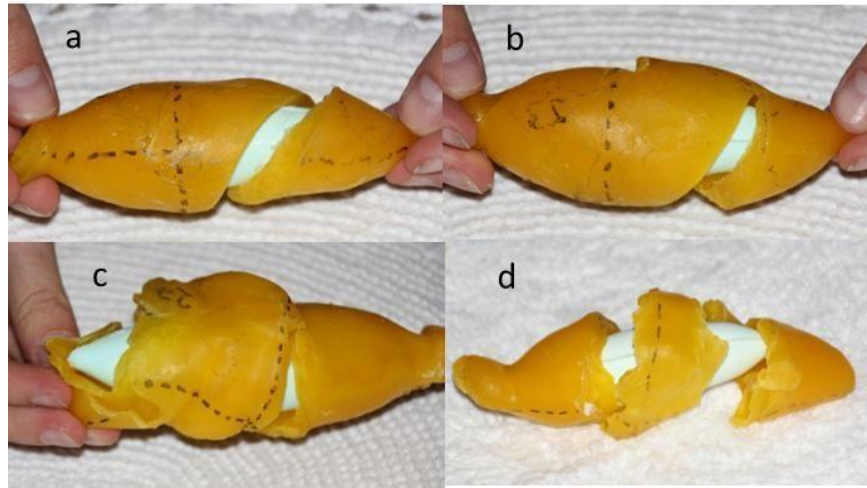
**Figure 10.** Damage resulting from replicates passing through a Kort nozzle. Figures 10a & 10b are images of the model shown in Figure. Note the damage comprised of a single smooth edged slice that cut through the wax layer and continued around the seal model in a spiral that rotated through approximately 450°. Images (c) and (d) show other examples of the damage resulting from the ducted propeller.

All seal models passing through the ducted propeller at 200 rpm and 400 rpm which demonstrated any characteristic damage received single curvilinear lesions (see example in Figure 9 and Figure 10). Lower proportions received characteristic lesions at higher propeller rotation speeds (Table 5). No single curvilinear lesions were seen at 1200 rpm (ranked propeller speed 4) however 21.43% did receive at least one characteristic injury at this speed.

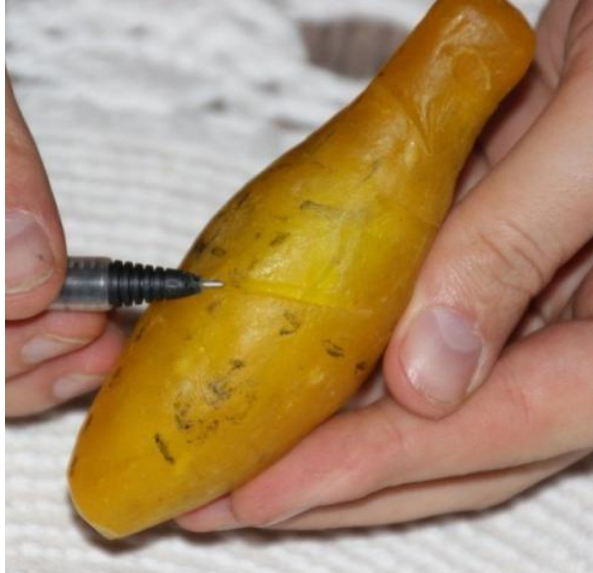
**Figure 12.** An example of damage resulting from a model passing through an open propeller. Note three separate impact marks: one indicated by the pointer, one on the front of the seal model and one at the rear. None of them resembled a spiral, curving wound and all were notably superficial with none cutting deeply into the wax layer.

Many of the seal models passing through the open propeller received superficial wounds, often resulting from multiple blade impacts. Twelve trials, all at 1200 rpm, resulted in wounds which cut through the wax layer. In five of these cases, the seal model jammed against the struts of the main support of the propeller and suffered additional tear wounds. These wounds can be assumed to be fatal damage given the depth and severity of the lacerations.

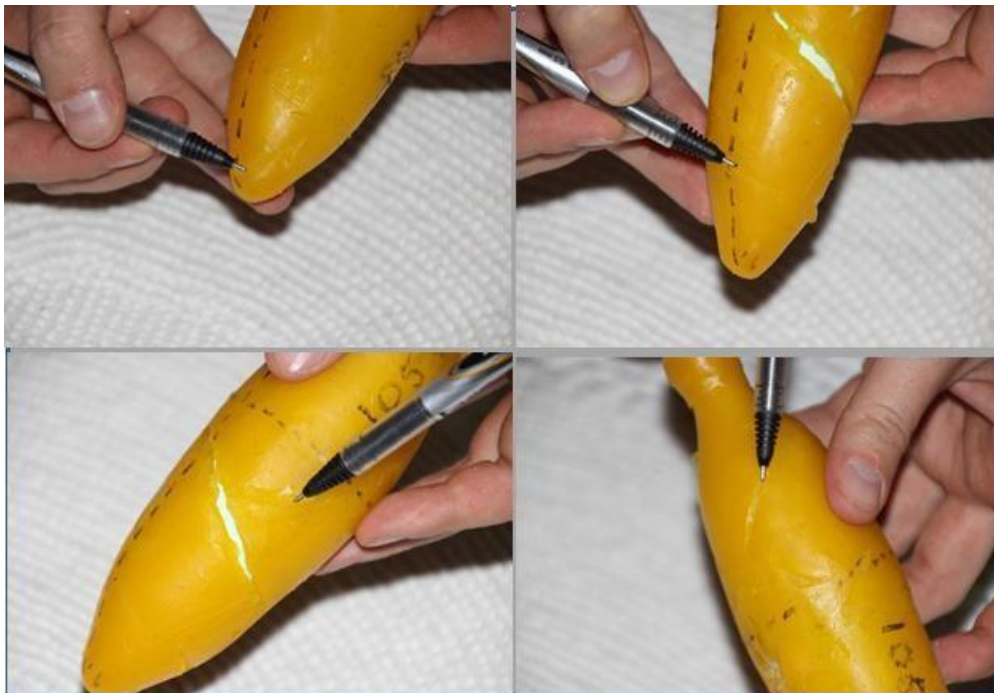
**Figure 13.** Multiple slice wounds, at different orientations due to passage through an open propeller.

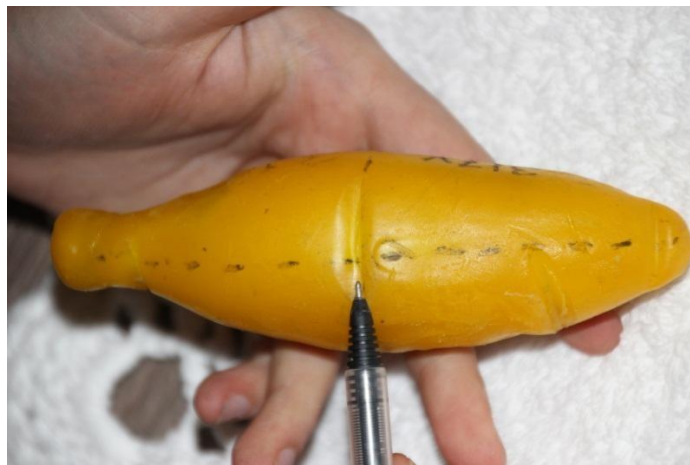
**Figure 15.** Figure shows the damage inflicted on the seal model by the collision with the Voith-Schneider Propeller

No characteristic lesions were observed on any seal models passing through the Voith- Schneider propeller. Many of the seal models received only superficial wounds, often resulting from multiple blade impacts. However, unlike the previous two mechanisms, no models tested with the Voith-Schneider propeller showed any visible signs of significant impact and did not demonstrate deep slicing damage. Seal models often received multiple blade impacts however were invariably knocked out of range of the rotating propeller and into the wake without sustaining significant or observable damage (Figure 13 and Figure 14).

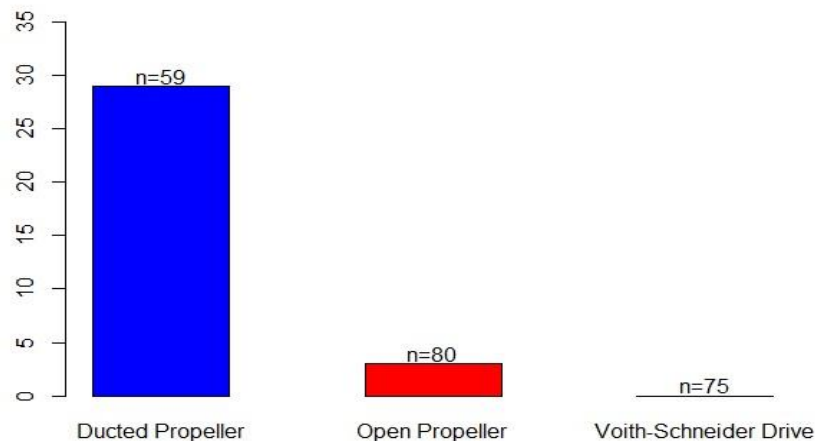
**Figure 17.** Histogram of the number of trials yielding a binary index score of one by propeller type.

The Chi-squared test confirmed that the production of any of the attributes was affected by propeller type ( $\chi^2 = 15.52$ ,  $p = <0.001$ ). No trials within the Voith Schneider propeller treatment group displayed any characteristic attributes and so were excluded from further analysis; all quantitative results in this treatment were equal to 0. A demonstration of this result can be seen in the histogram in Figure 17.

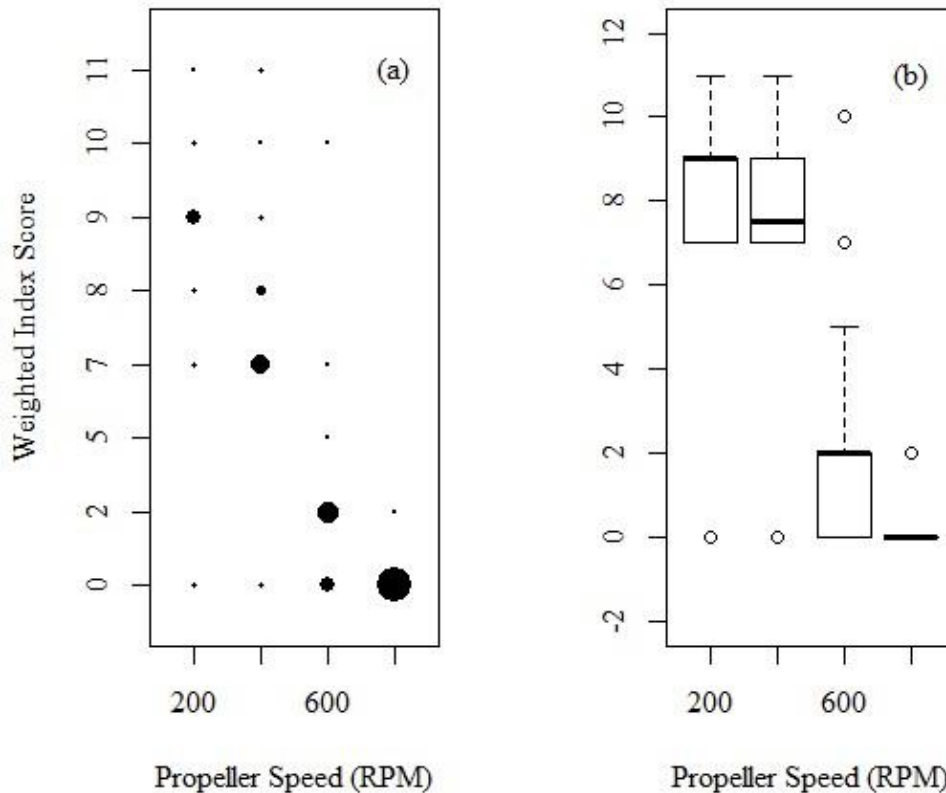
**Figure 18.** (a) Dot plot demonstrating the weighted index scores as a function of propeller speed in the ducted propeller treatment group. The size of the dot indicates the number of trials in that value. (b) Boxplot of weighted scores against propeller speed. A significant distinction between propeller speeds of below 400 RPM and above 600 RPM can be seen suggesting a threshold value of between 400 and 600 RPM under which characteristic corkscrew lesions are more likely.

The negative binomial GLM demonstrated that propeller speed significantly affected the weighted score in the ducted propeller treatment group (Table 8). Slower speeds produced more characteristic wound patterns than faster speeds with maximum rpm yielding no examples of single linear lesions comprising one or more rotations; the attribute with the largest weighting index (Figure 18). Changes in seal model size had no effect on the weighted scores (table 8). Fitted values from the negative binomial GLM are demonstrated in Figure 19. Confidence limits for weighted index values can be seen to overlap with regards to model size (Figure 19). This further supports the result that model size is not a good predictor of wound patterns. For both

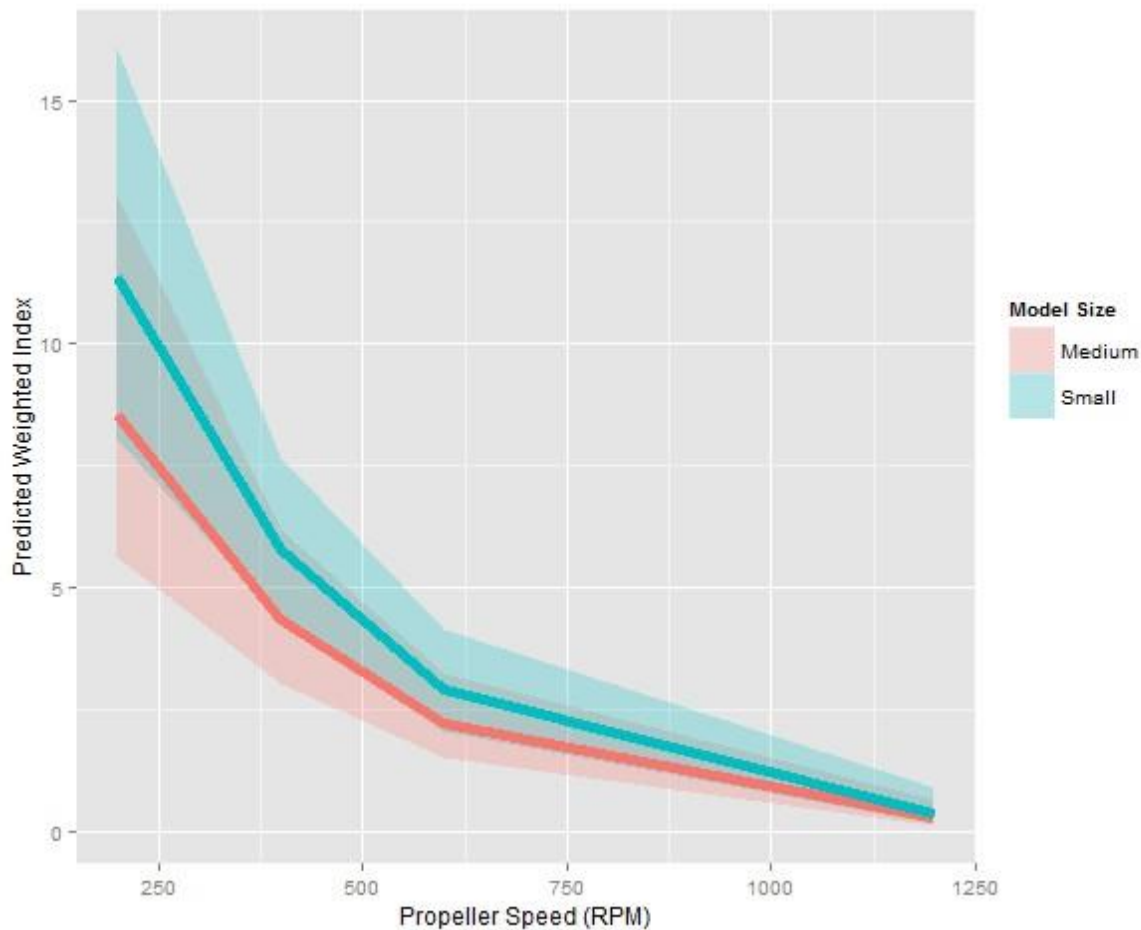
**Figure 19.** Fitted weighted index values from negative binomial regression.
